PORT ACTIVITY AND ENDANGERED SPECIES: POSSIBLE BANK SWALLOW

COHABITATION CHALLENGE
OVERCOME

A PILOT PROJECT OF THE
QUÉBEC PORT AUTHORITY
(QPA)

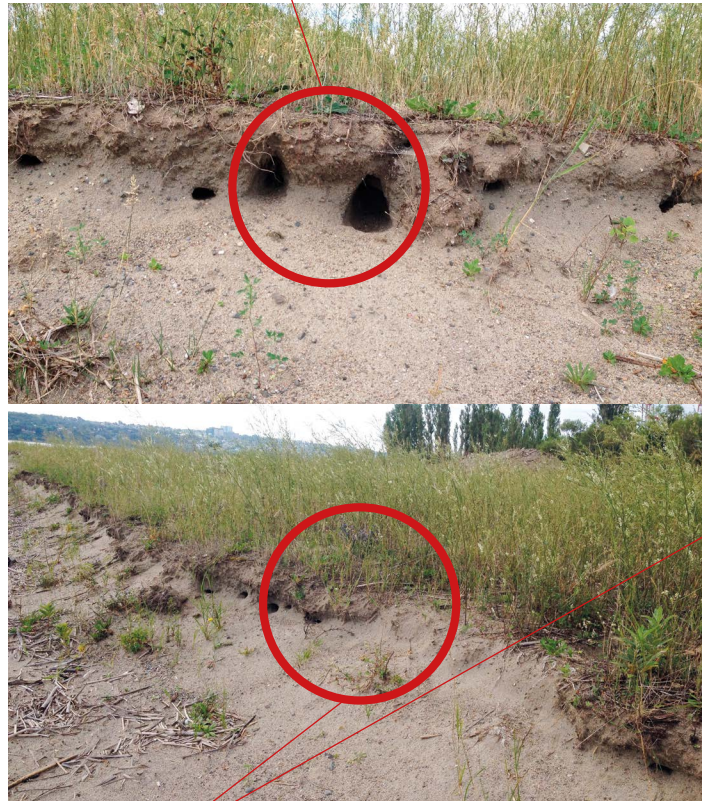
Holes enlarged by predators, with claw marks at hole entrances.

Signs of predation in the natural habitat in 2014

Here, signs of predation are clearly visible on the burrows dug in the natural habitat.

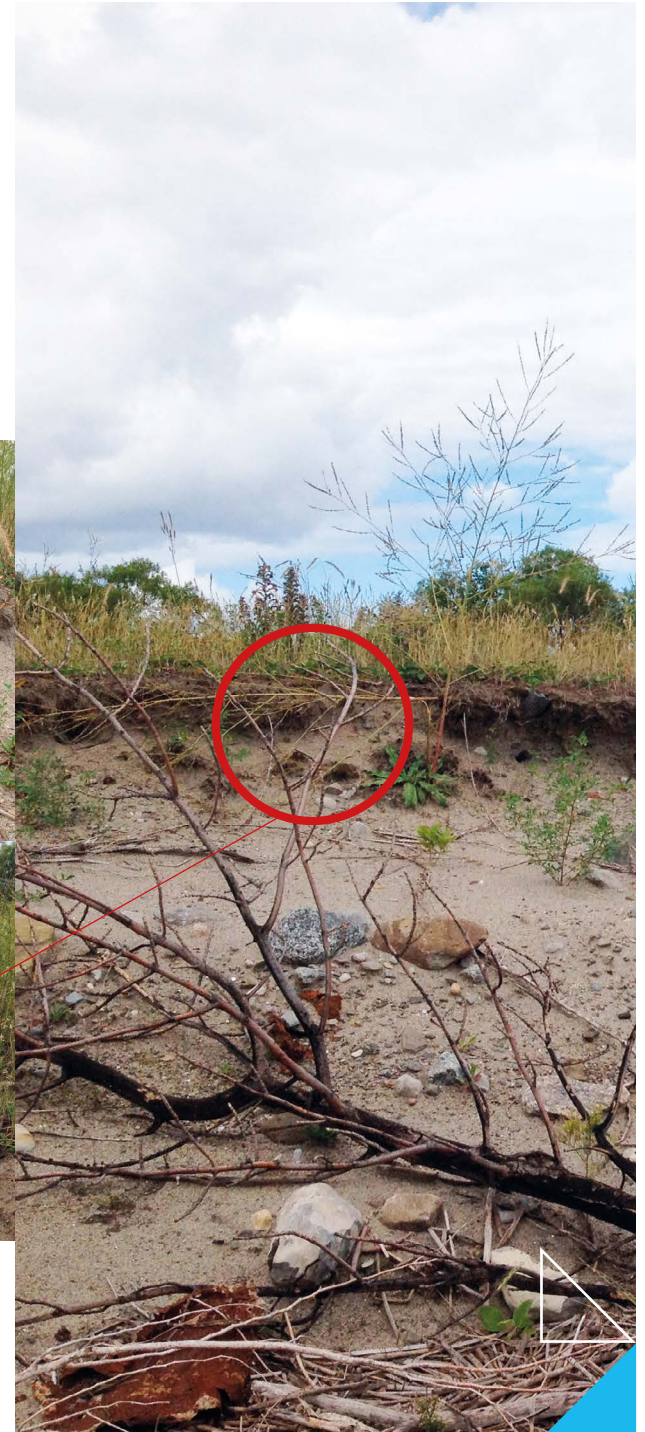
Habitat is very low to the ground, which exposes it to tides and weather as well as predators.

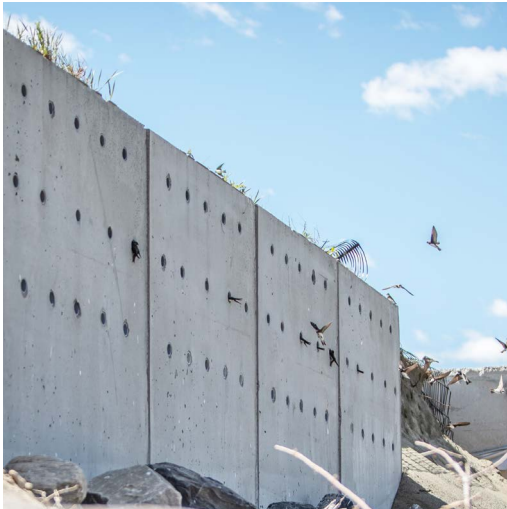
A.

Concrete walls with premade holes.
Technical aspects are illustrated on page 9.

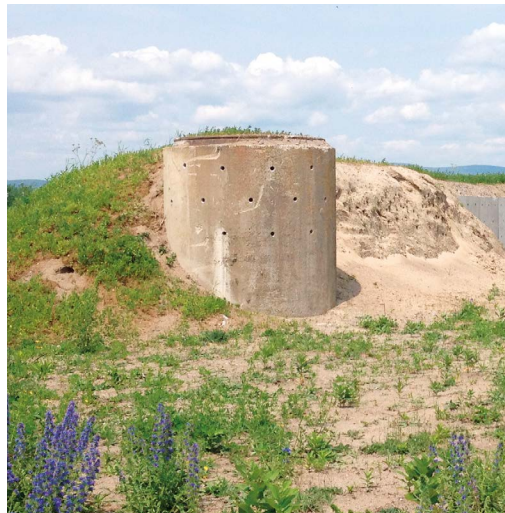
B.

Vertical concrete pipes with
premade holes.

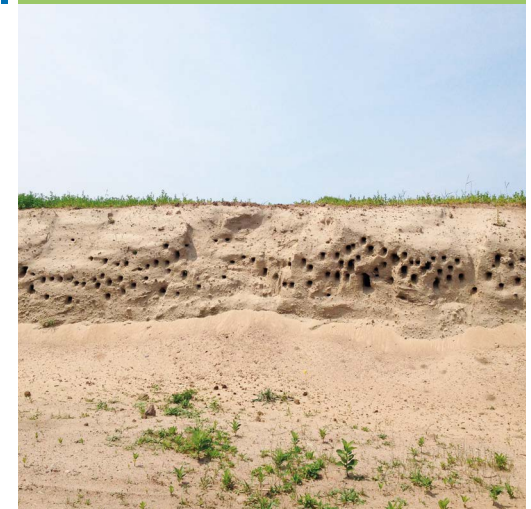
C.

Engineered vertical sand
banks *(since there was no
guarantee that the swallows
would nest in the concrete).*

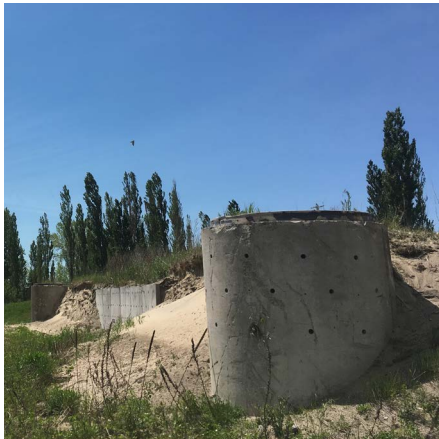
Since the pre-pierced vertical concrete pipes were little used in the first structure, this feature was not incorporated into the 2018 structure.

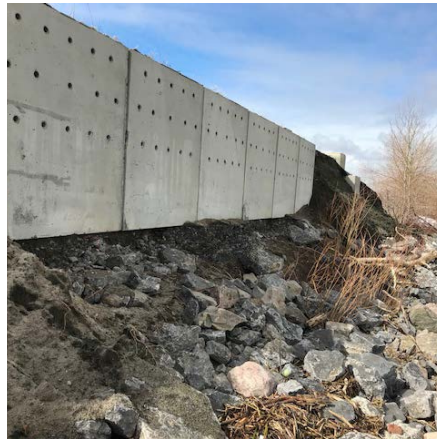
The sand banks were smaller than those of the 2015 structure, in order to encourage use of the concrete walls.

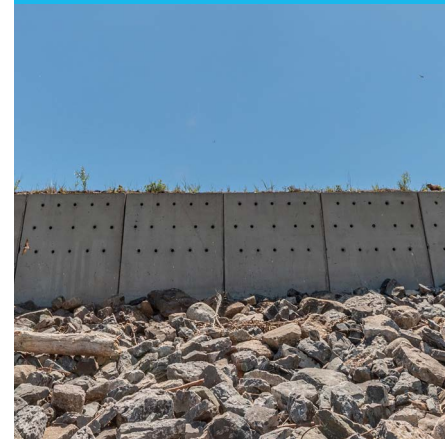
The premade holes in the concrete walls were clustered more densely than in the initial 2015 structure.

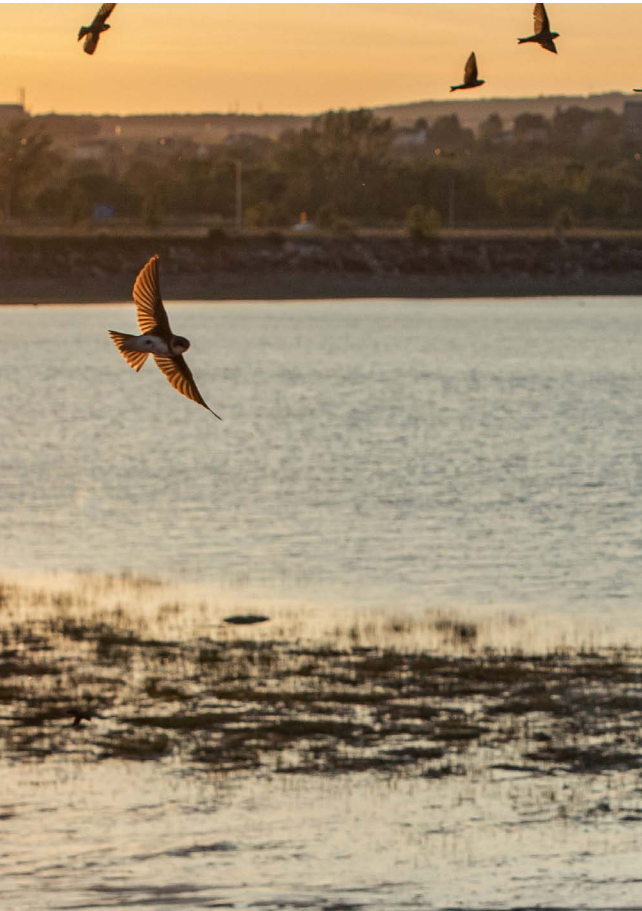
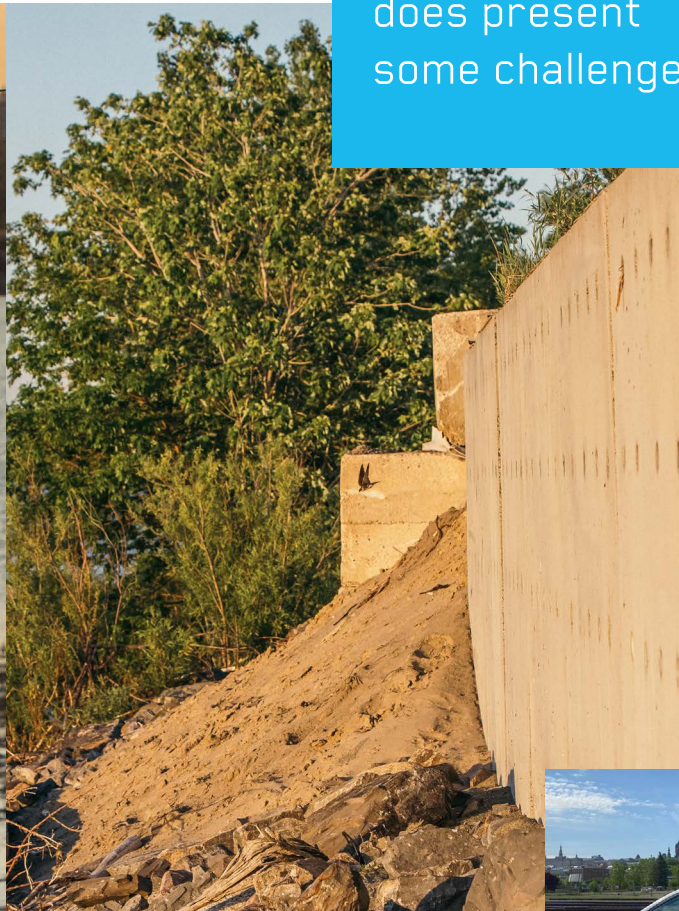
Nesting structures at the edge of a beach are exposed to erosion and tides.

Curious users of Beauport Bay may potentially disturb the colony.

- ▶ Accordingly, a fence and warning signs were installed to limit colony disturbances.
- ▶ Our security agents also provide some surveillance of the facilities.
